Fargo, ND | HEI No. 1915-0241

September 30, 2019

ENGINEER'S DESIGN REPORT – ADDENDUM #1

Lower Otter Tail River Channel
Restoration

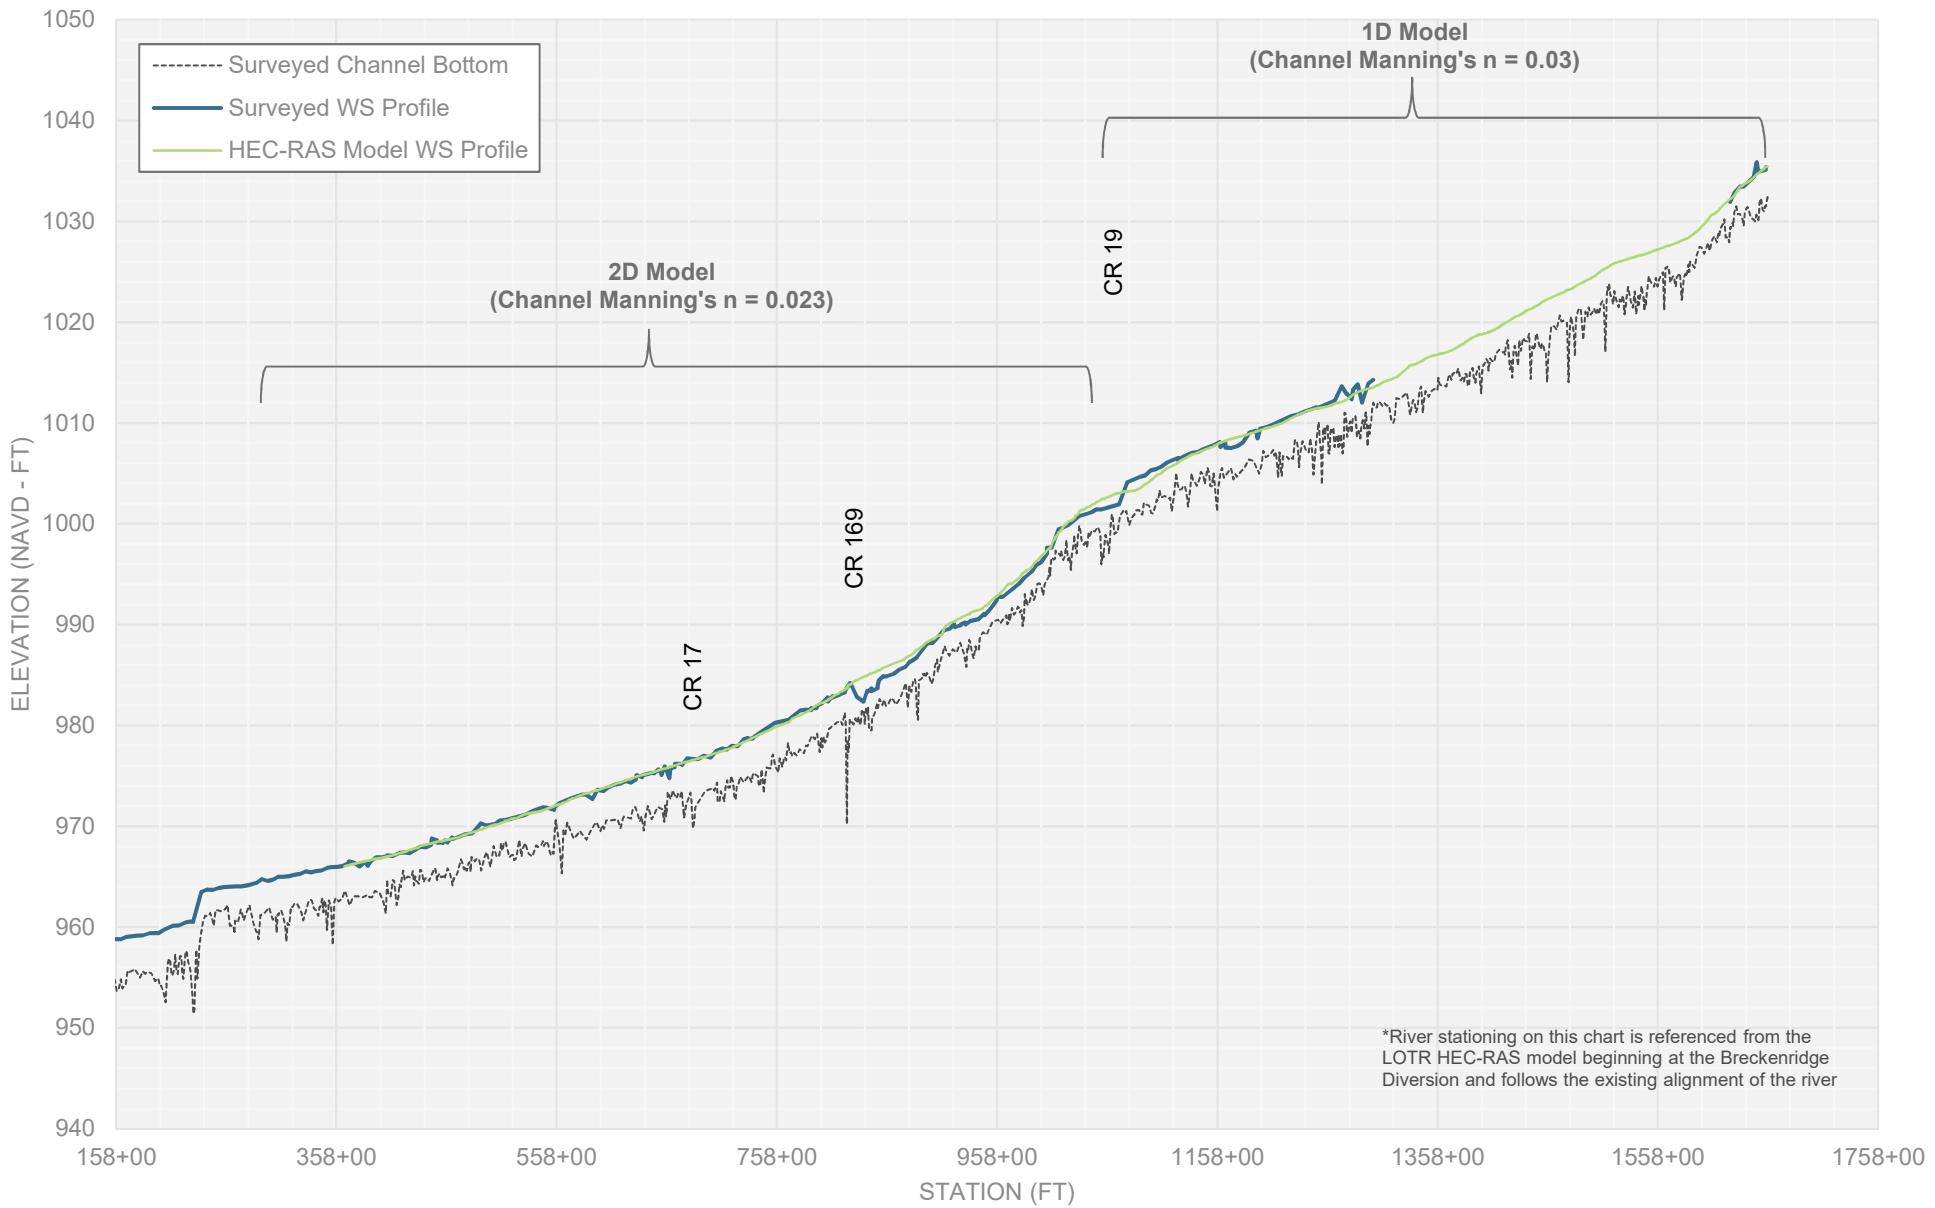
EXHIBIT 1: CALIBRATION PROFILES

[Exhibit 1](#) shows the new calibration results of the 2D model compared to the surveyed water surface elevation on the day of surveying (approximated to be a flow of 713 cfs). The calibration profile is consistent with the accuracy of the 1D calibrated profile as well as the previous 2D calibrated profile. It was determined that a manning's roughness coefficient (n) of 0.023 would be used to represent the existing roughness of the straightened channel.

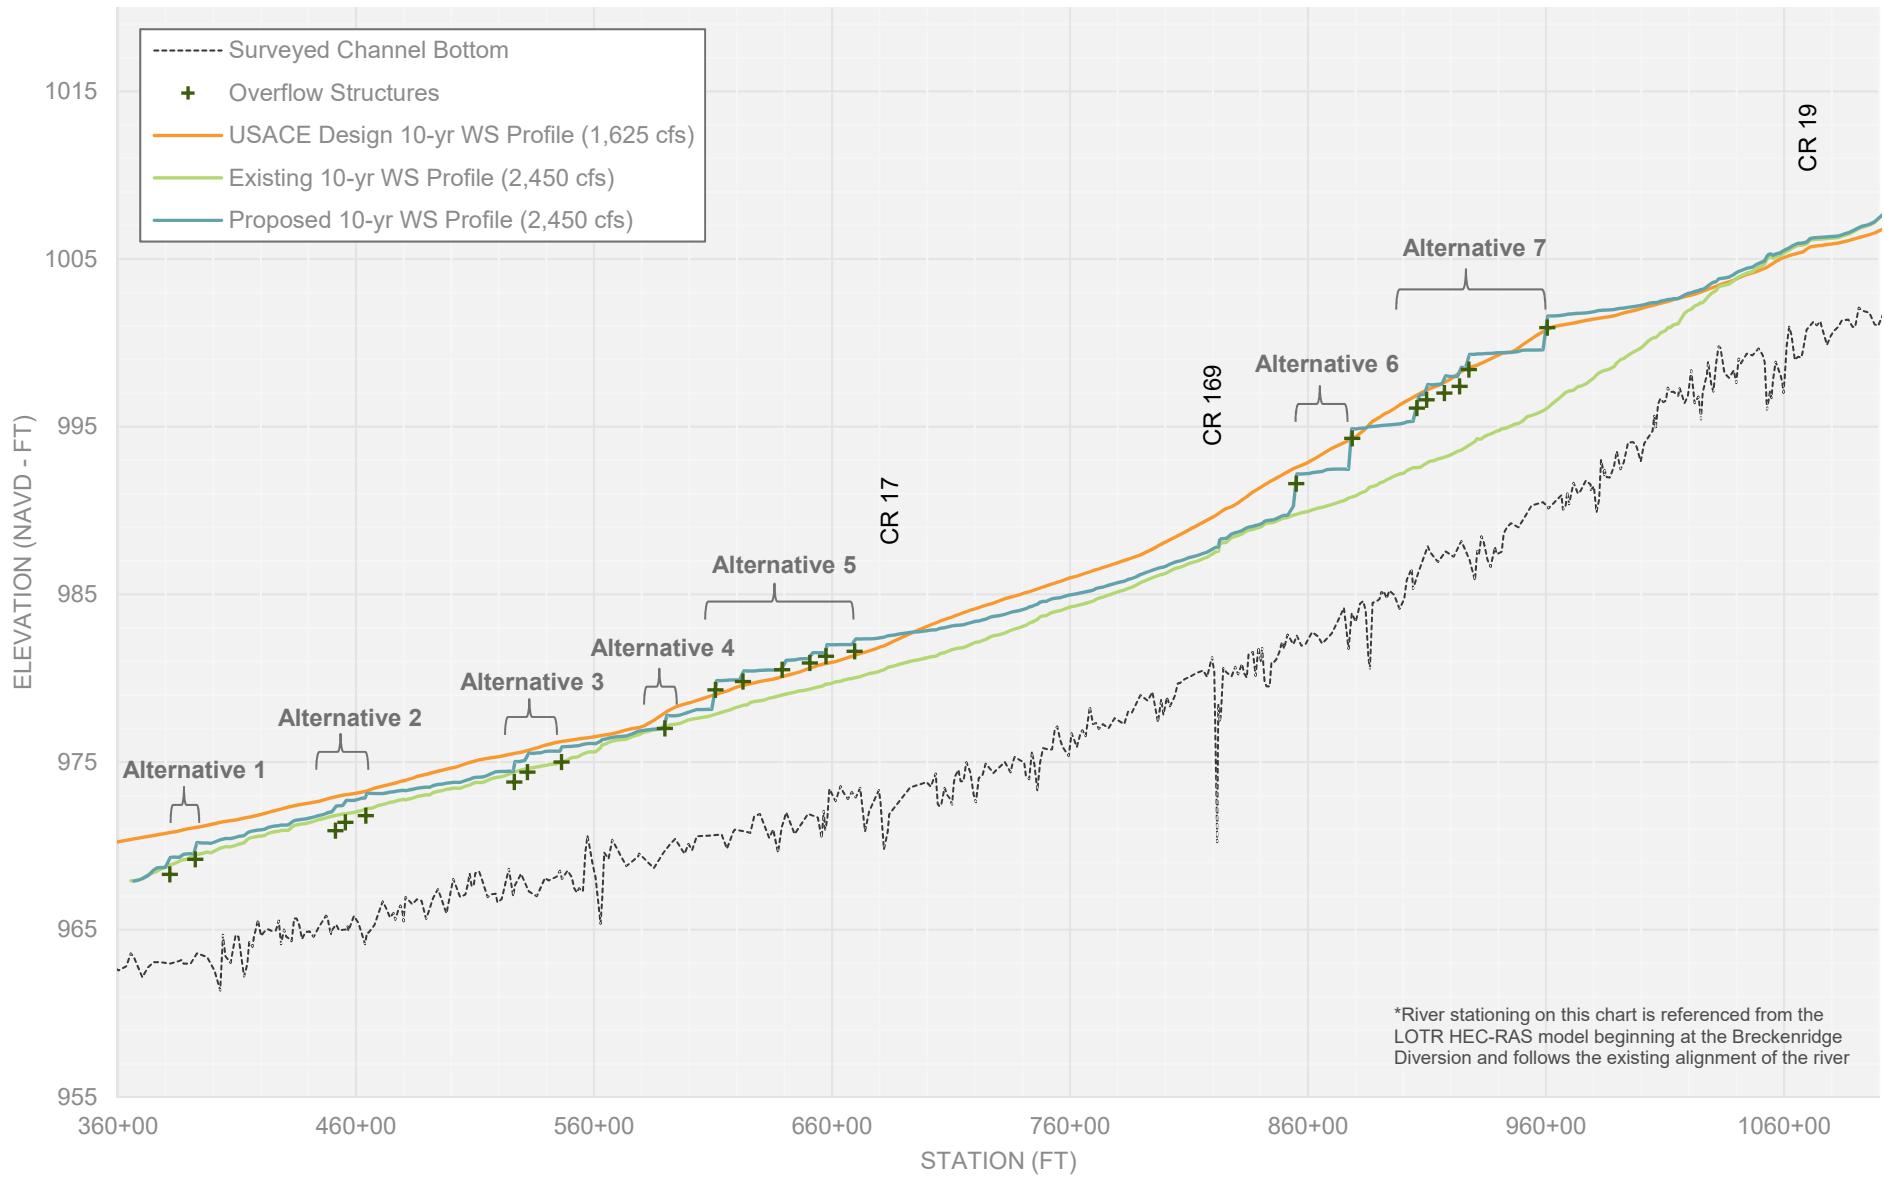
EXHIBIT 2: 10-YEAR DESIGN EVENT PROFILE COMPARISON

Modifications to the restoration design were made to accommodate the larger 10-year design flow and maintain the same level of protection as the 1953 USACE project. These modifications are discussed in Section 3 of this report. There is approximately a 50% increase in flow from the original USACE design flow (1,625 cfs) to the current 10-year peak discharge. This causes an increase in flooding even with the modifications to the restoration design. [Exhibit 2](#) compares the USACE 10-year water surface profile with the existing and proposed conditions water surface profiles. Results show that the proposed 10-year water surface profile is above the USACE 10-year water surface profile near alternatives 5 and 7. [Exhibit 3](#) shows the inundation for the proposed 10-year flood compared to the 1950's inundation for a 10-year flood. Due to the drastic changes in dimension and profile of the river over the years, some areas experience worse flooding while others see an improvement from the 1950's.

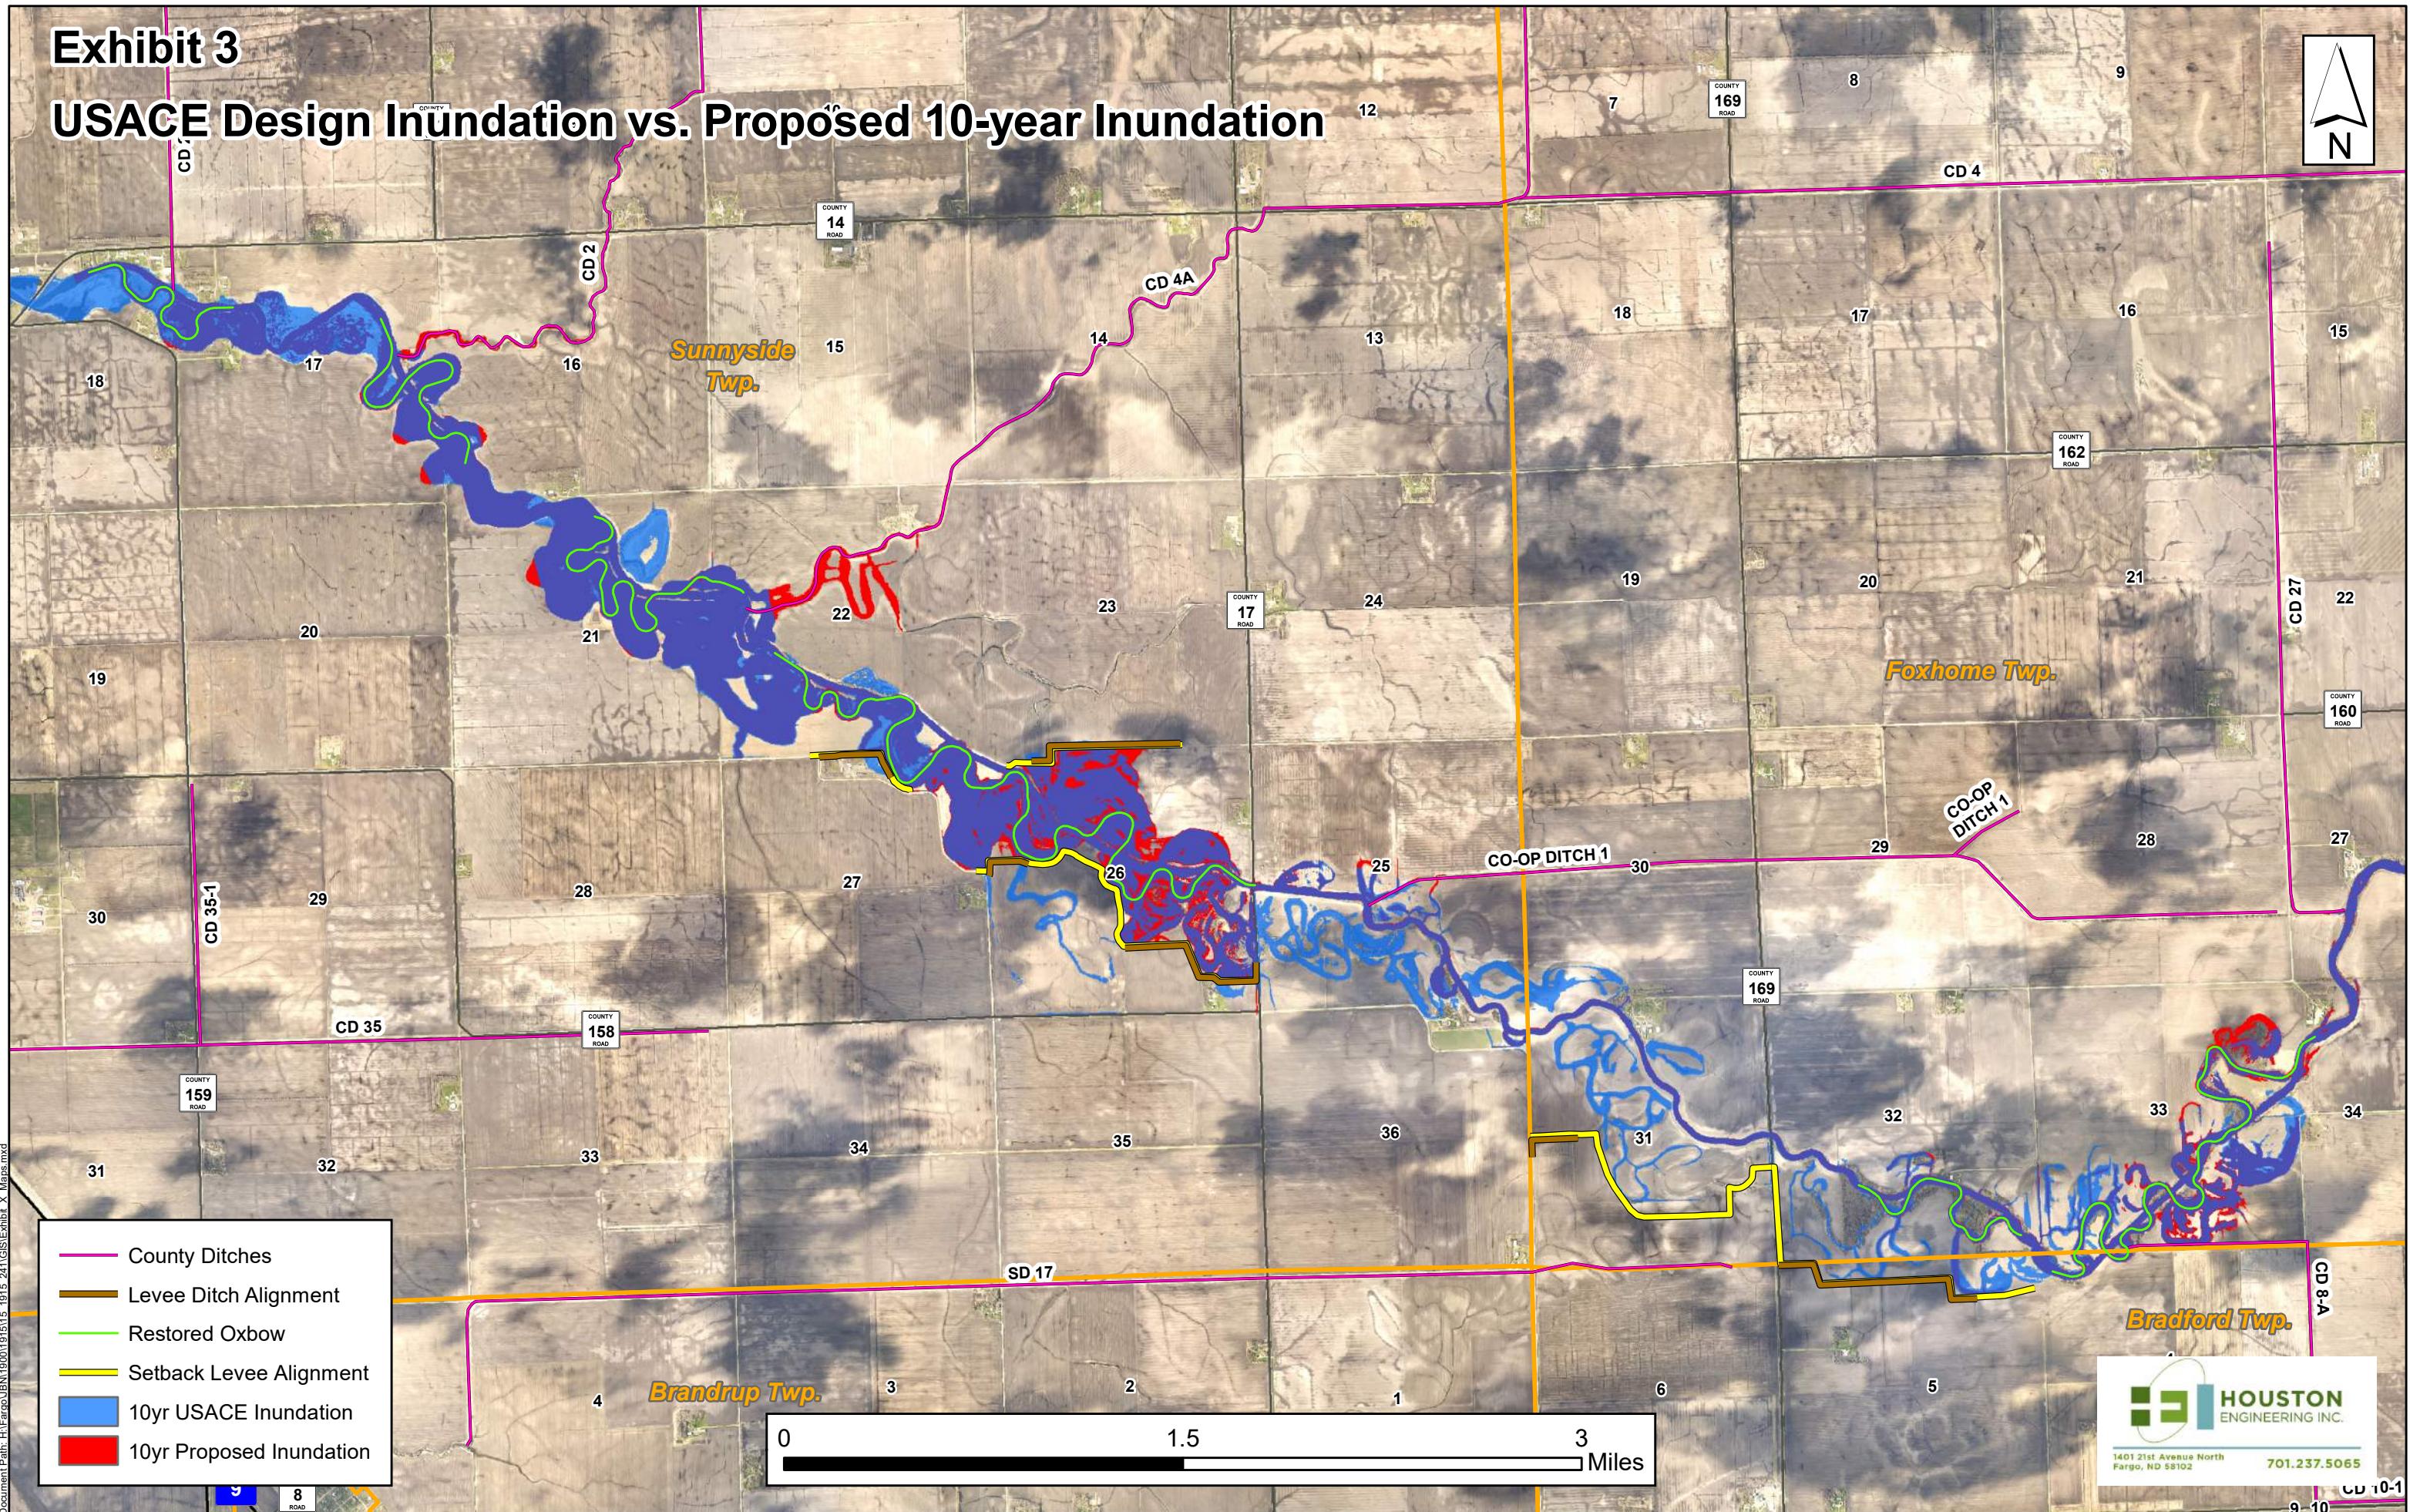
Exhibit 3

USACE Design Inundation vs. Proposed 10-year Inundation

Significant degradation and widening through erosion of the river channel have led to lower flood levels in this area of the Lower Otter Tail River. Flowage easements are the principal mitigation measure for the 10-year event and will be purchased in areas that experience an increase in flooding due to the restoration project. These flowage easements will help to reestablish a floodplain corridor along the river. Setback levees will be constructed in some areas to reduce inundation beyond the desired floodplain corridor. Although the setback levees are primarily used during a 100-year flood, they provide some functionality during the 10-year event as well. [Exhibit 4](#) shows the proposed setback levee alignments and compares existing conditions 10-year inundation to proposed 10-year inundation.

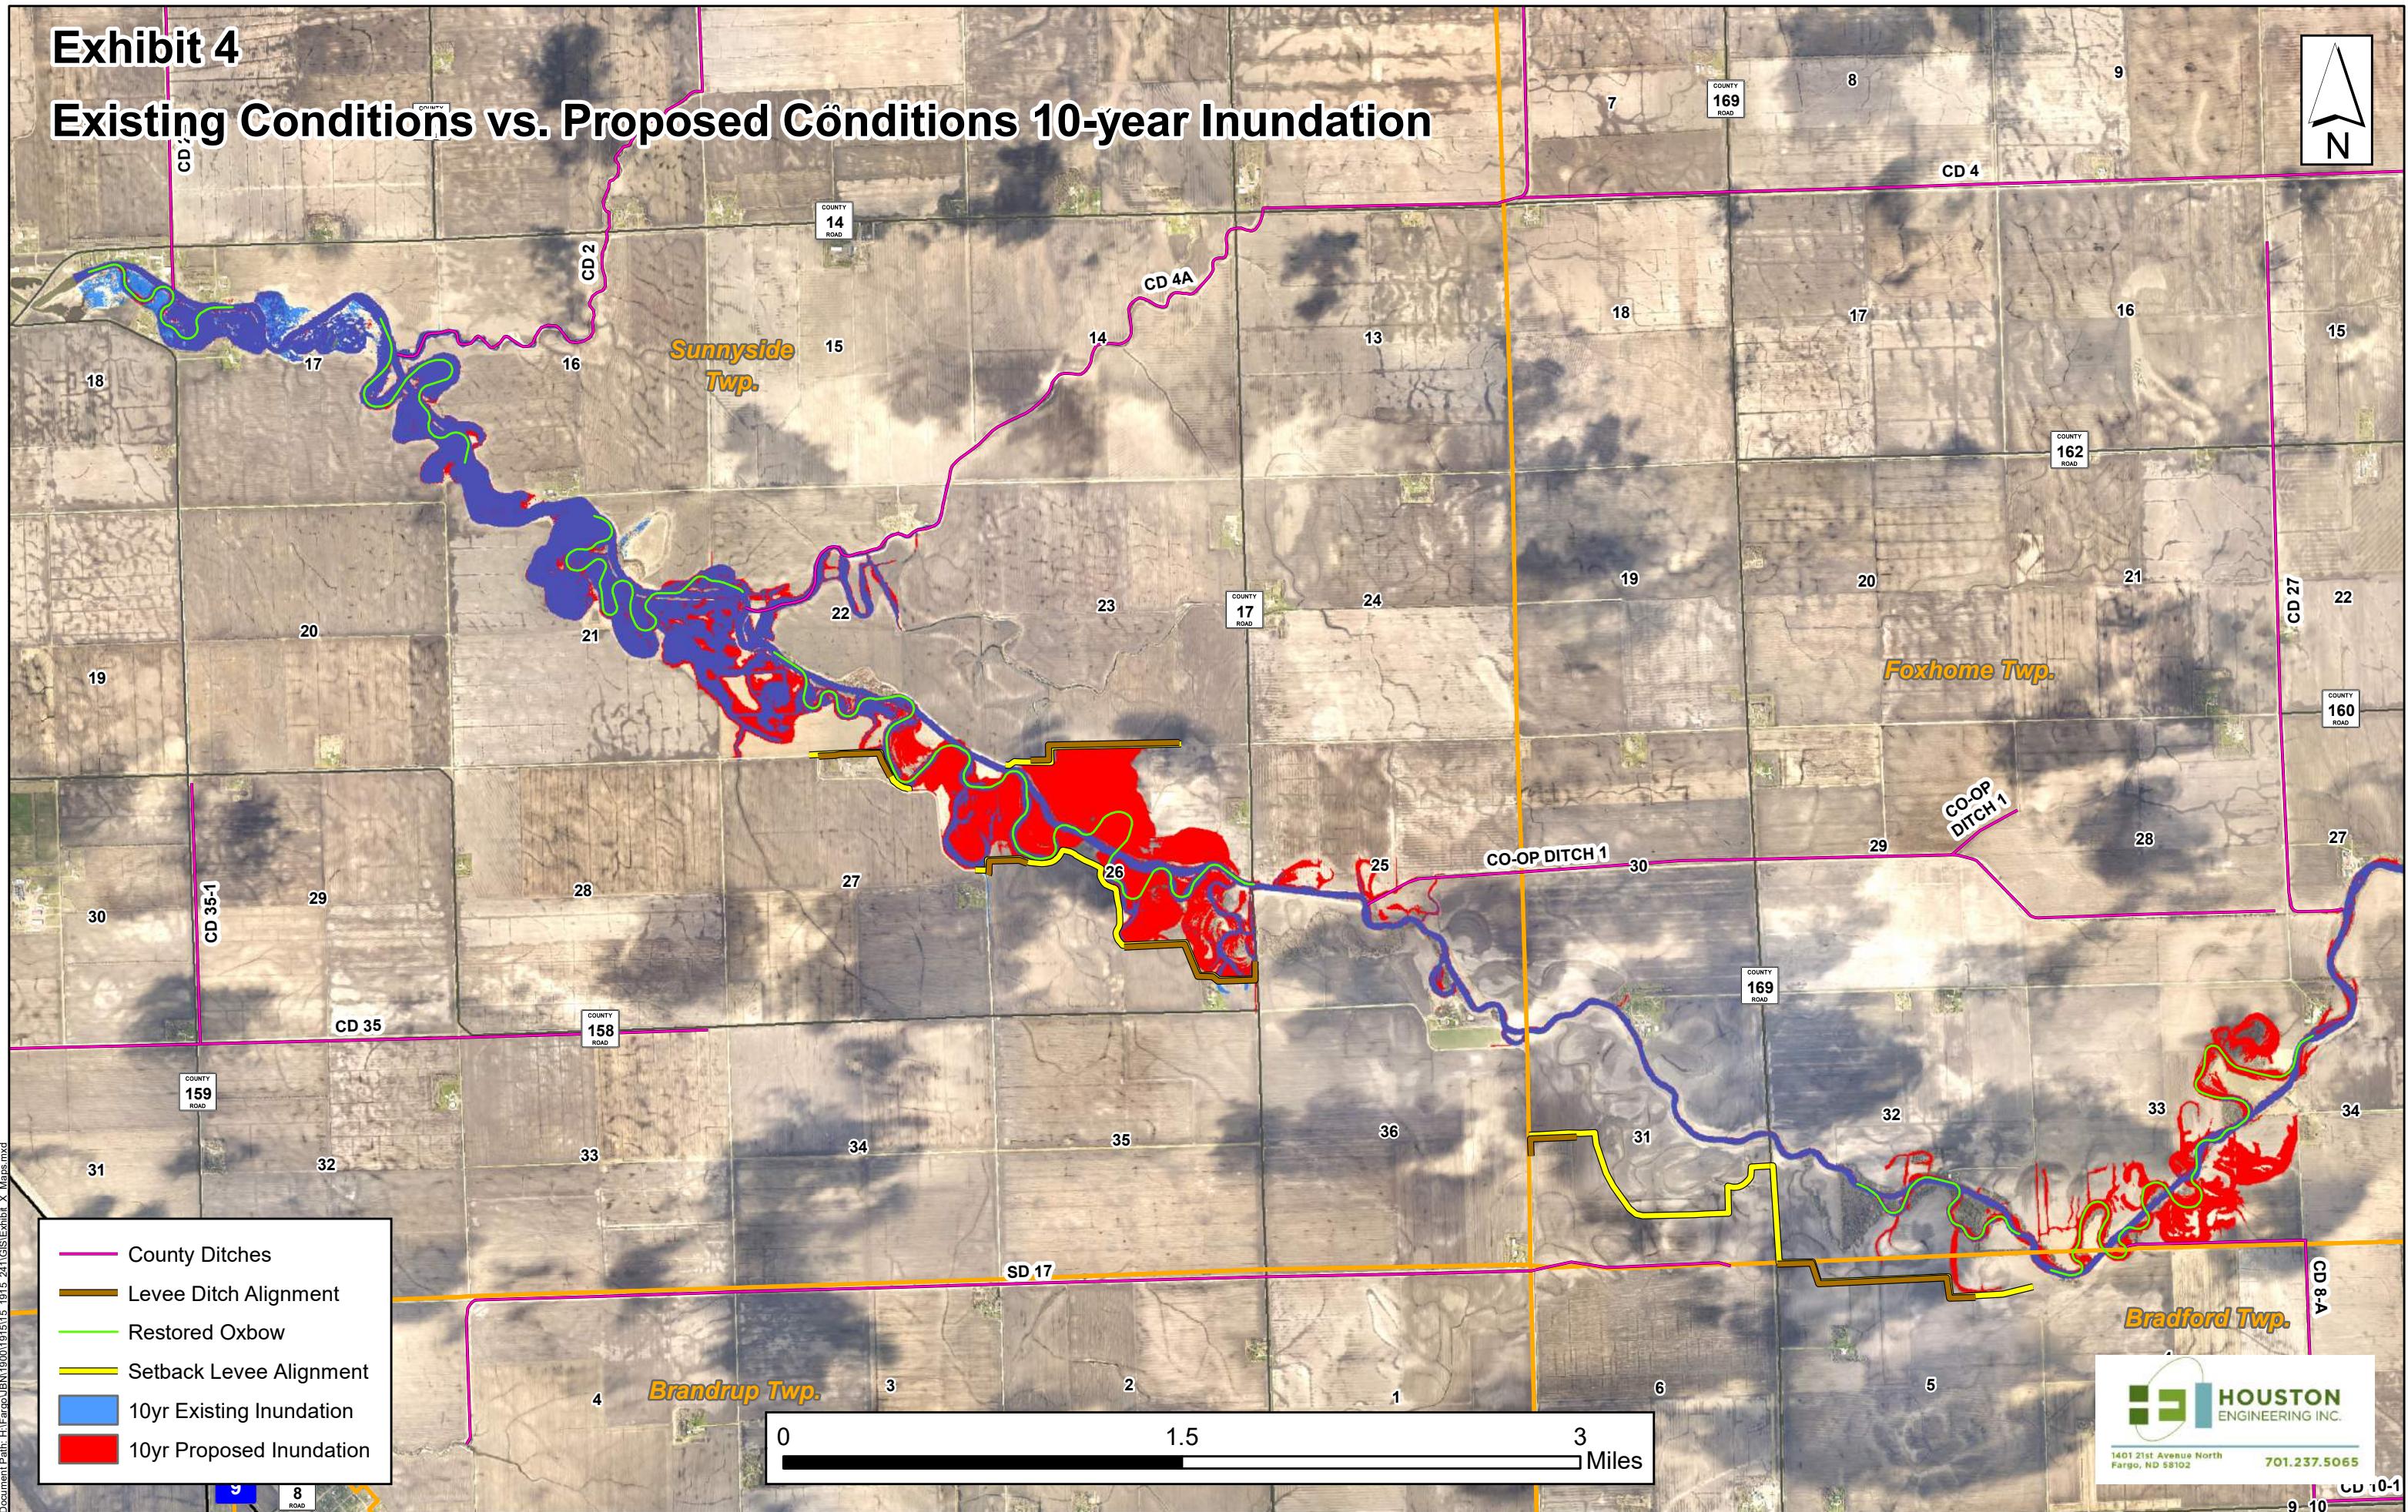
Exhibit 4

Existing Conditions vs. Proposed Conditions 10-year Inundation

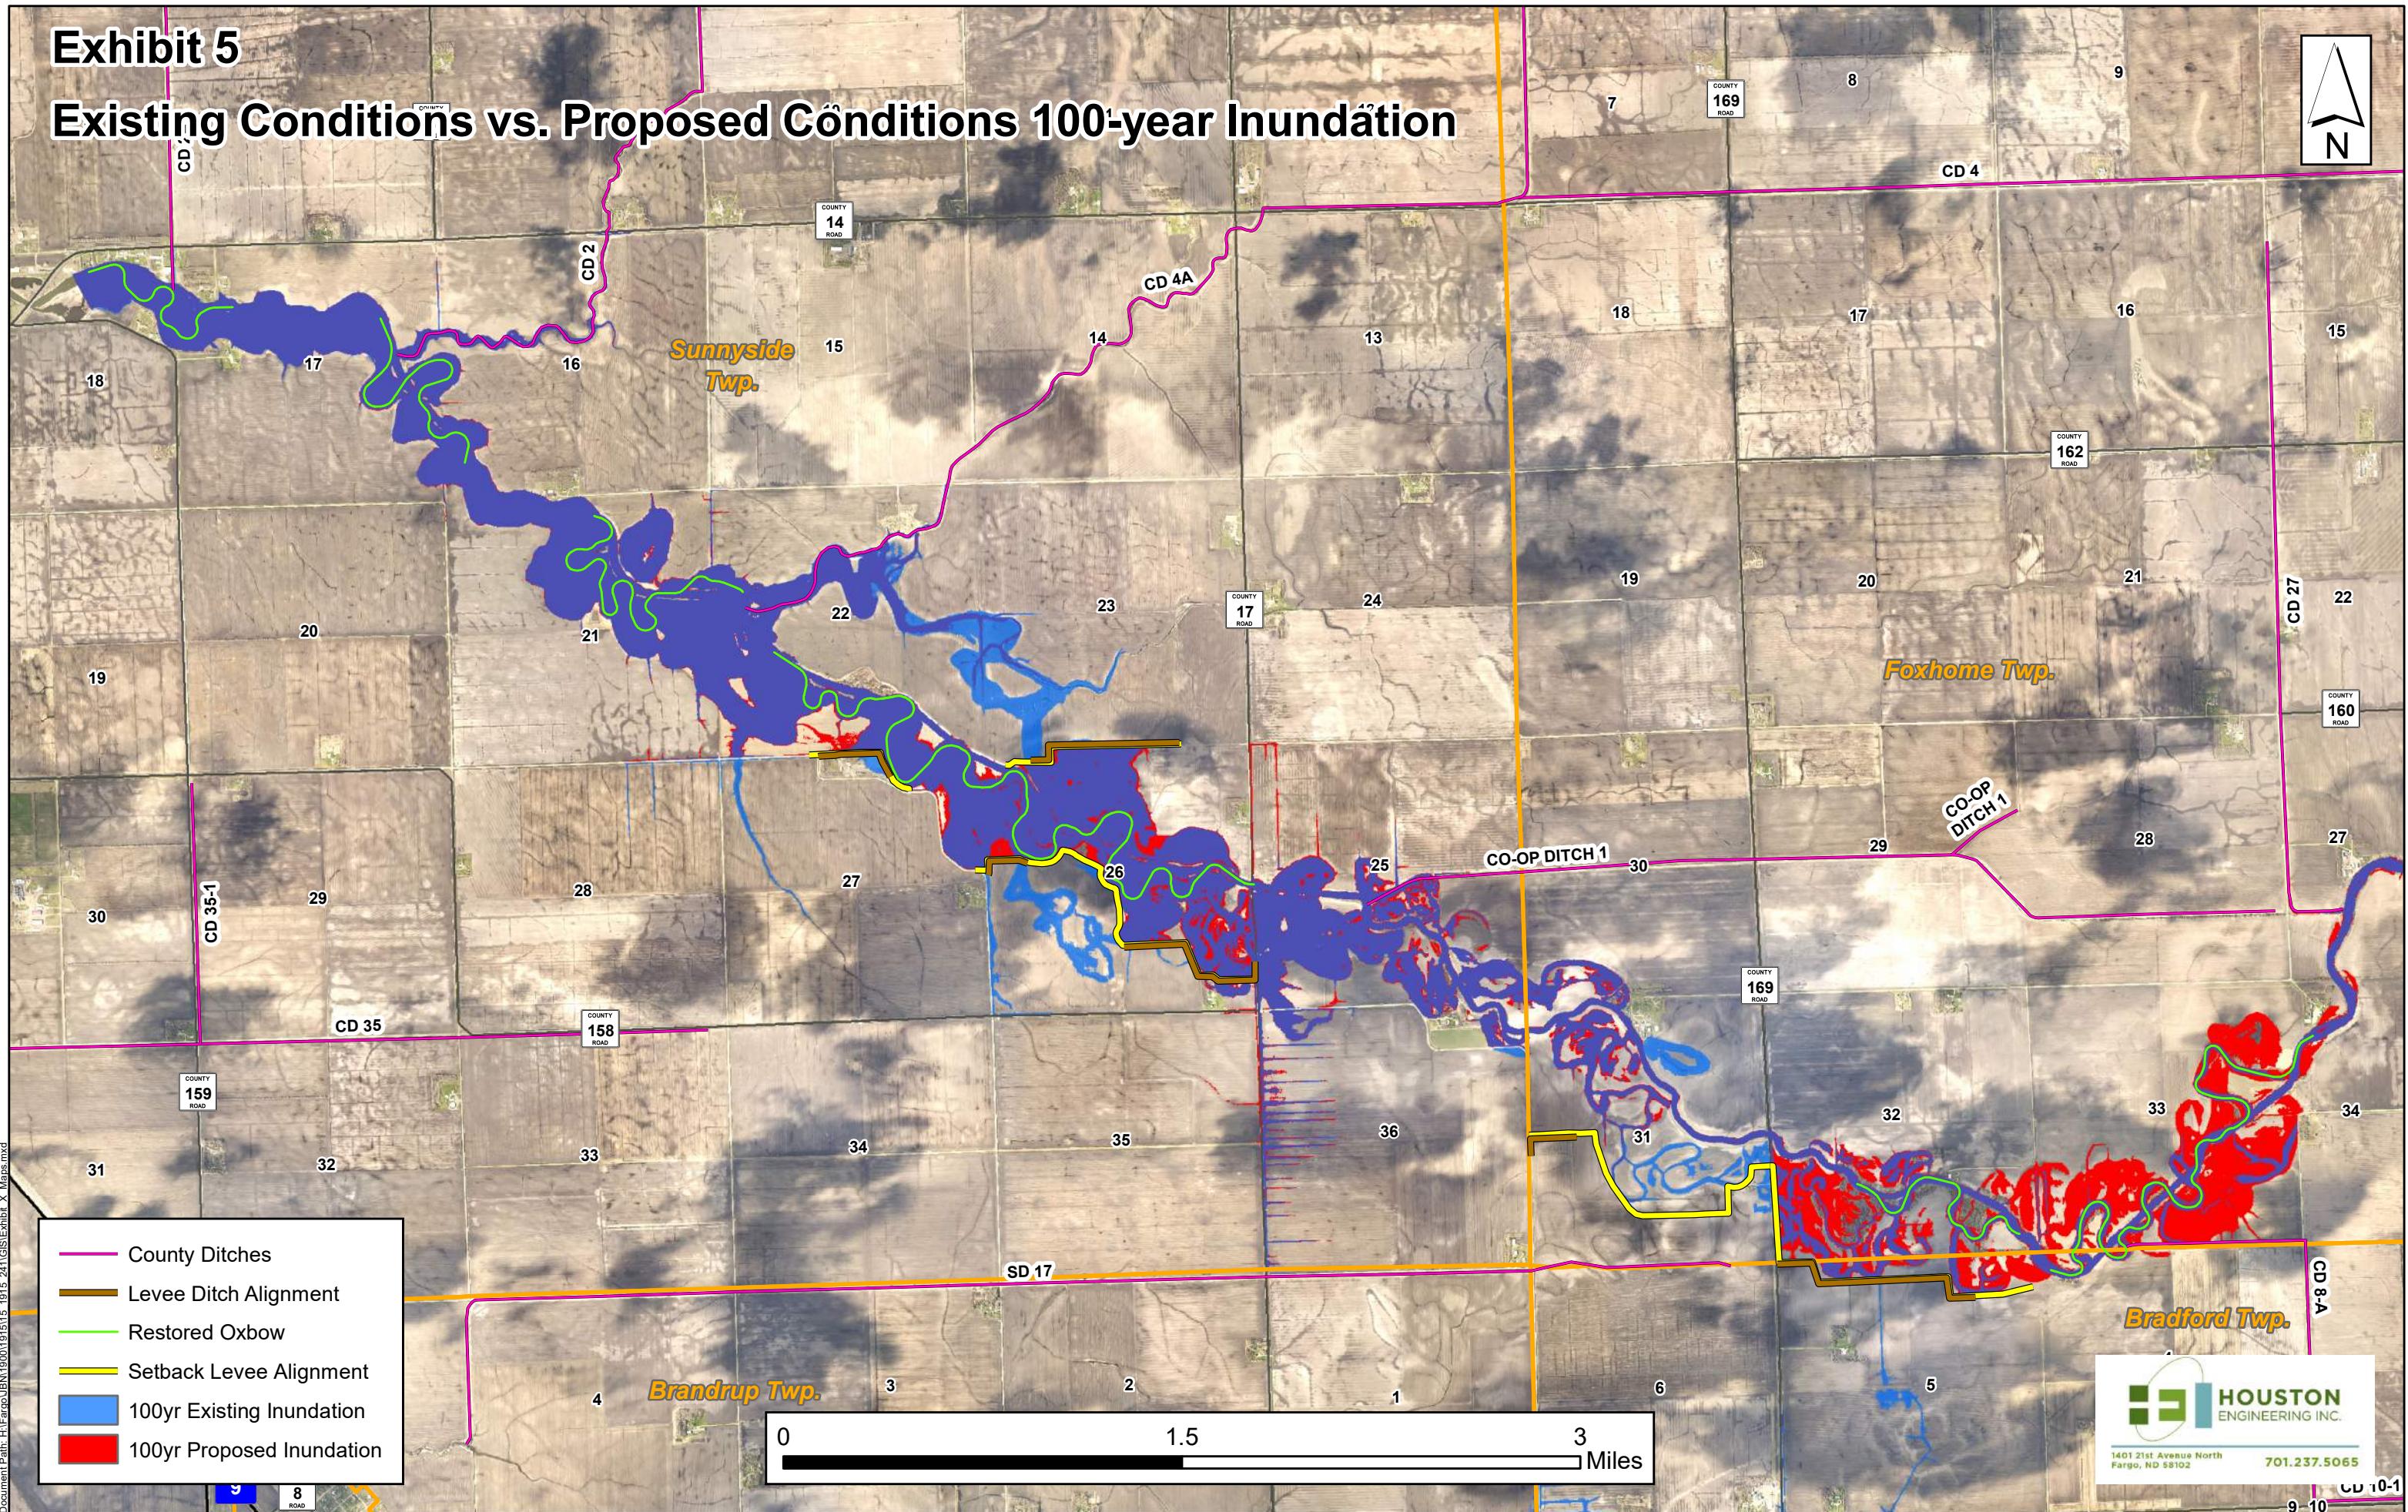
Exhibit 5

Existing Conditions vs. Proposed Conditions 100-year Inundation

The 2017 100-year FIS peak flow was analyzed in the original design report in Section 5.3.2. A total of five setback levee alignments were proposed for the 100-year event to establish a floodplain corridor and prevent breakout flows from leaving the drainage area. The proposed mitigation for the 100-year event is unchanged from the original analysis. [Exhibit 5](#) compares existing conditions 100-year inundation to proposed 100-year inundation for the 2017 FIS peak flows.

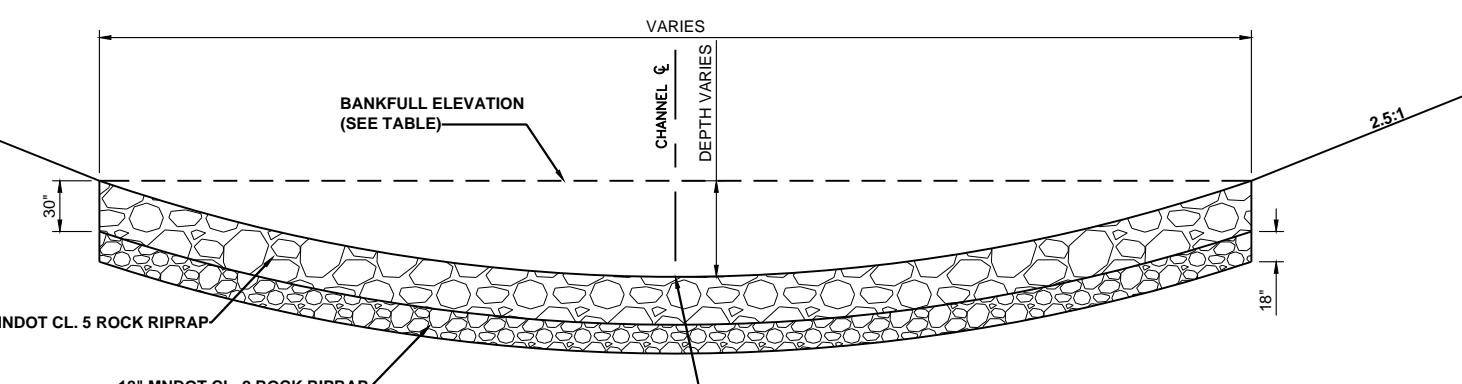
SECTION A - A
NOT TO SCALE

Riffle Structures						
Alternative	Oxbow	From Station	To Station	Channel Elevation at Top of Riffle	Bankfull Elevation	Bankfull Width
27	9008+98	9008+68		963.54	968.04	122.5
27	9018+18	9017+88		963.65	968.15	122.5
26	9026+08	9025+78		963.79	968.29	122.5
26	9031+19	9030+89		963.85	968.35	122.5
26	9033+96	9033+66		963.88	968.38	122.5
26	9039+89	9039+59		963.96	968.46	122.5
25	8013+65	8013+35		965.2	970.1	124.5
24	8046+14	8045+84		965.56	970.46	124.5
22	8056+42	8056+12		965.81	970.71	124.5
22	8062+43	8062+13		966.22	971.12	124.5
21	7007+95	7007+65		967.37	971.87	122.5
21	7010+38	7010+08		967.41	971.91	122.5
21	7012+35	7012+05		967.44	971.94	122.5
21	7023+40	7023+10		967.62	972.12	122.5
21	7029+43	7029+13		967.72	972.22	122.5
21	7031+92	7031+62		967.76	972.26	122.5
21	7042+25	7041+95		967.93	972.43	122.5
20	7051+59	7051+29		968.33	972.83	122.5
20	7064+59	7064+29		968.97	973.47	122.5
19	7076+47	7076+17		969.8	974.3	122.5

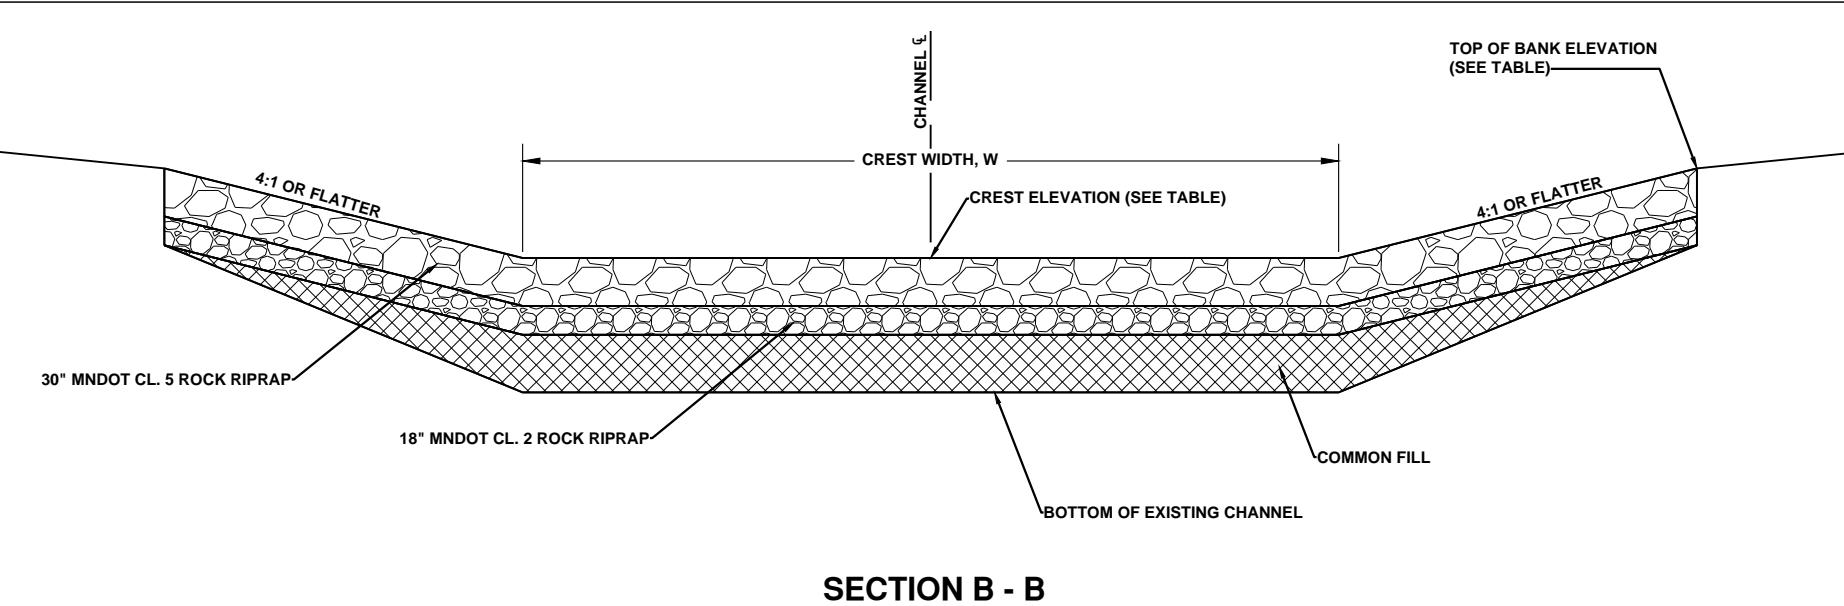
SECTION B - B
NOT TO SCALE

Overflow Structures								
Alternative	Oxbow	Begin Station	End Station	Total Length L	Crest Width W	Crest Elevation	Structure Height H	Top of Bank Elevation
1	27	491+37	490+65	72	140	968.3	5.3	972.8
	26	500+85	500+09	76	150	969.2	5.7	973.3
2	25	561+68	560+94	74	150	970.9	5.5	982.2
	24	565+10	564+32	78	170	971.4	6	978.1
3	22	573+18	572+38	80	140	971.8	6.2	977.5
	21	635+80	635+02	78	150	973.8	6	976.6
4	20	642+40	641+56	84	150	974.4	6.8	979.5
	19	656+80	655+92	88	140	975	7.3	976.4
5	18	701+06	700+22	84	150	977	6.7	979
	17	720+75	719+80	95	130	979.3	8.1	982.3
6	16	733+15	731+99	116	140	979.8	10.7	982.7
	15	750+05	749+07	98	130	980.5	8.5	981.3
7	14	762+50	761+46	104	160	980.9	9.3	982.3
	13	771+80	770+72	108	130	981.3	9.7	982.6
8	12	781+90	780+88	102	140	981.6	9	986.2
	9	967+85	966+74	111	140	991.6	10.1	998.8
9	8	988+50	987+34	116	140	994.3	10.8	1000.8
	7	1019+50	1018+46	104	120	996.1	9.3	999.7
10	6	1022+90	1021+82	108	170	996.6	9.8	1001.3

Overflow structures are incorporated into the preliminary design downstream of each of the oxbow inlets at the main river channel. These overflow structures serve two purposes. The first is to ensure that the normal run of the river is redirected into the restored oxbow rather than through the straightened reach, even if the restored oxbow is at a higher grade line than the existing channel. The second purpose of the overflow structures is to alleviate upstream stage increases during large flood events. Through bank erosion and channel degradation the existing channel has a much higher carrying capacity than it was designed for in the 1950's. Restoration of the meanders increases the hydraulic profile in each of the alternative regions. At a minimum, bankfull discharge (approximately 1,150 cfs) must be directed through the restored meanders in order for the channel restoration to provide ecological benefits. This will establish stable stream conditions and allow natural geomorphic processes to occur. Therefore, the overflow structure heights were set at the approximate bankfull depth for each of the alternatives.

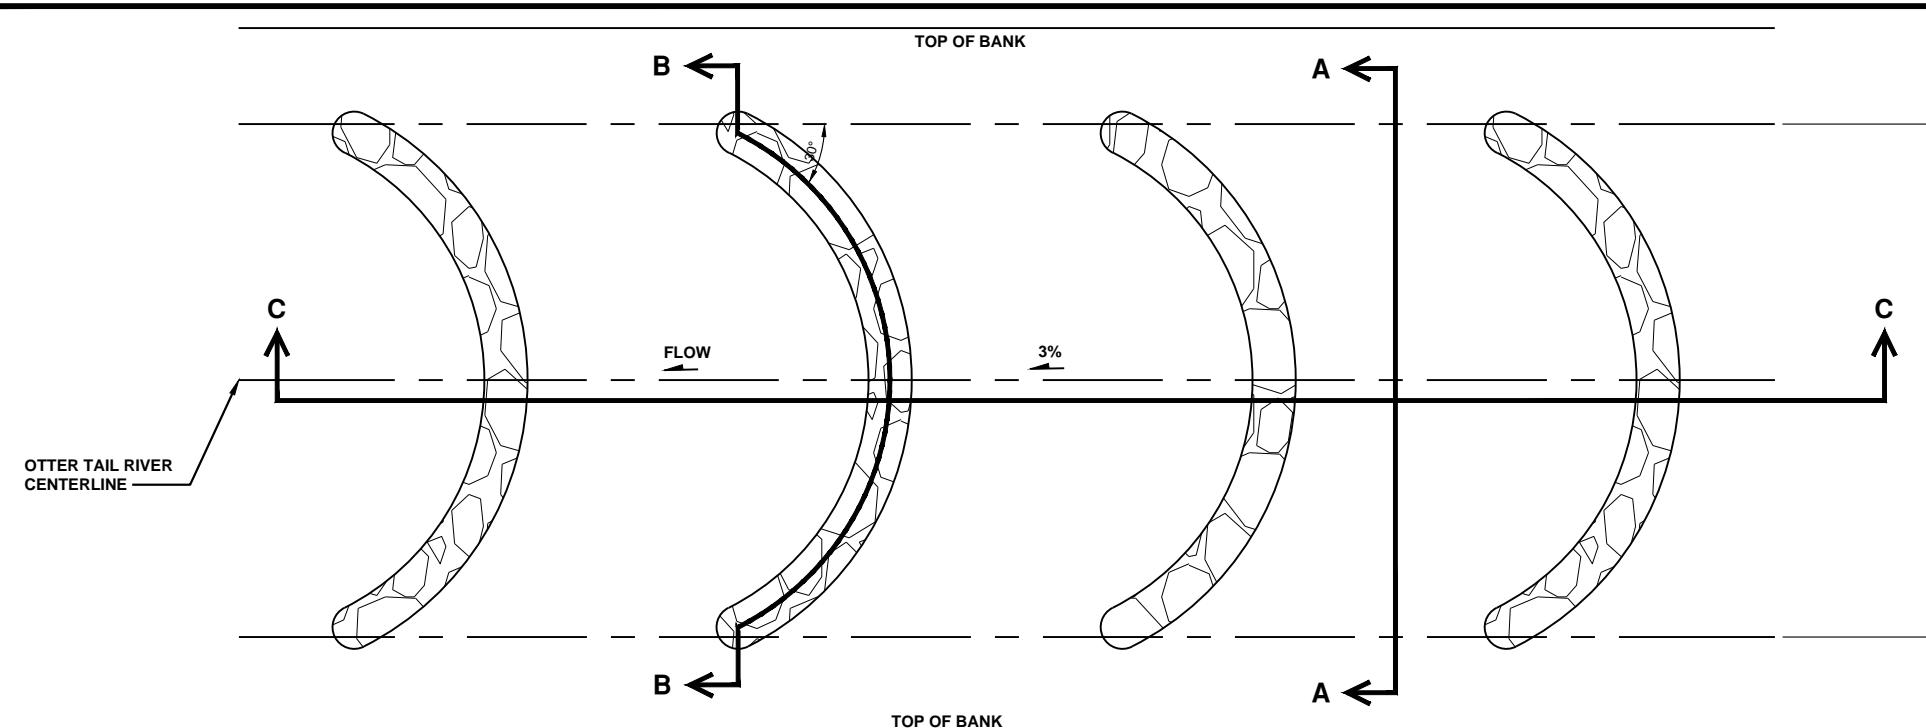
GRADE CONTROL - TYPICAL PLAN VIEW

Grade Control Structures								
Alternative	Oxbow	From Station	To Station	Total Length L	Structure Width W	Crest Elevation	Structure Height H	Number of Boulder Weirs
3	19	7073+38	7072+64	74	130	969.7	1.5	2
4	18	6006+17	6005+40	77	130	971.8	1.3	2
5	17	5006+26	5004+67	159	130	974.5	3.8	5
6	9	4003+29	4001+40	189	130	985.9	4.2	6
	8	4025+71	4023+44	227	120	987.3	4.3	6
7	7	3095+75	3094+25	150	90	992.8	4.1	6
	1	3002+23	3000+73	150	120	998.8	3.7	5

5. THE WEIRS FUNCTION TO PROVIDE ADDED STABILITY TO THE RAPIDS, RESTING AREA FOR THE MIGRATION OF FISH, DIRECTING FLOW TOWARDS MID-CHANNEL (REDUCING STRESS ON BANKS) AND INCREASING SAFETY BY CREATING LOW VELOCITIES NEAR BANKS.

6. WEIRS ARE TO BE INTEGRATED INTO THE CONSTRUCTED BANKS. THE GAPS BETWEEN BOULDERS SHALL TYPICALLY RANGE FROM 0 TO 6 INCHES.
7. ALL FILL MATERIAL UNDER RIPRAP RAMP TO BE EITHER EXCAVATED CHANNEL MATERIAL OR SELECT GRANULAR.

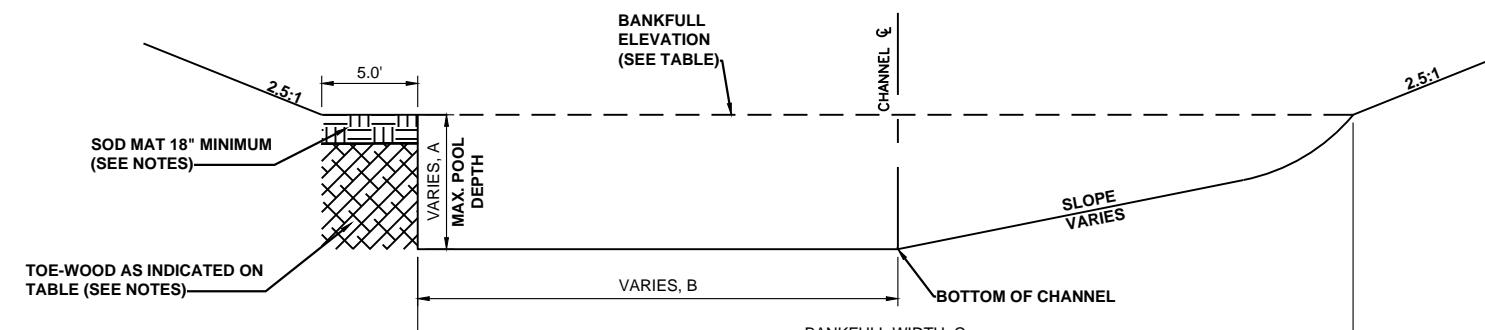
TOE-WOOD TYPICAL SECTION

Toe-Wood Locations				
	From Station	To Station	Length - feet (along Toe-Wood CL)	Bankfull Elevation
Alternative 6	4007+55	4011+99	514	990.48
	4027+63	4029+19	184	991.72
	4030+64	4032+89	259	991.93
	4033+99	4035+71	198	992.16
	4035+77	4037+78	231	992.29
	4037+96	4040+10	247	992.43
	4040+33	4042+80	286	992.6
	4043+39	4045+45	231	992.82
	4046+92	4048+00	134	993.06
	3007+31	3008+71	205	993.24
Alternative 7	3009+02	3011+82	349	993.31
	3011+82	3014+47	287	993.41
	3020+06	3022+35	253	993.73
	3022+43	3025+31	333	993.82
	3025+46	3028+10	298	993.94
	3030+37	3033+65	356	994.13
	3035+71	3038+72	334	994.34
	3038+72	3041+88	386	994.44
	3042+13	3042+79	82	994.56
	3047+39	3049+60	247	994.83
Alternative 8	3049+72	3052+88	366	994.94
	3054+01	3056+31	249	995.2
	3057+35	3059+08	199	995.4
	3059+66	3063+11	390	995.54
	3065+50	3070+47	537	995.86
	3070+77	3075+63	549	995.92
	3076+09	3077+24	142	996.38
	3097+48	3100+18	308	997.1
	3108+67	3111+58	343	997.71

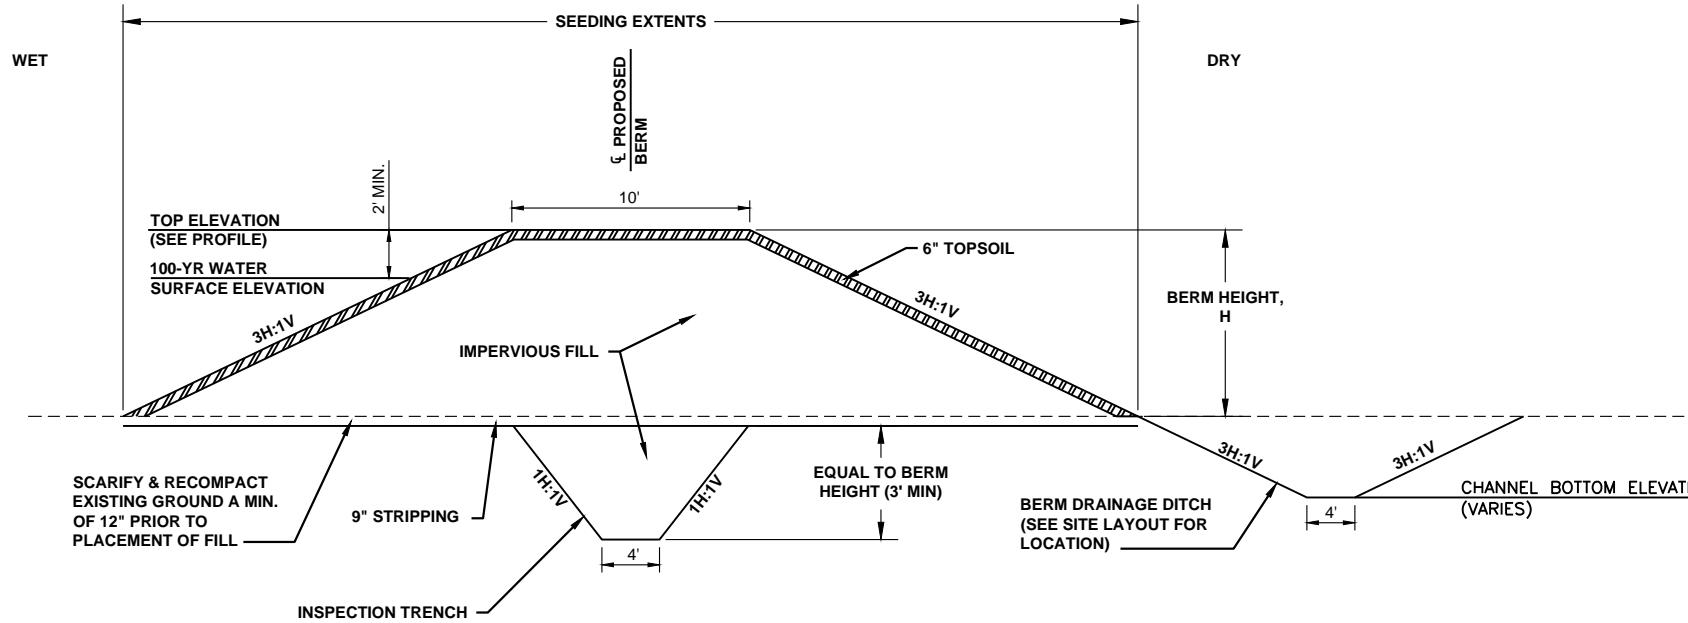
SETBACK LEVEE TYPICAL SECTION

Setback Levees						
Alternative	Levee Alignment	Length	Beginning Elevation (Upstream)	End Elevation (Downstream)	Maximum Levee Height	Length of Levee Ditch
5	1	2,440	981.50	981.2	4	1,720
5	2	3,830	984.70	982.5	5	4,480
5	3	7,840	983.60	983.6	5	3,260
1-7	4	6,650	993.90	990.8	5	1,250
1-7	5	7,710	997.60	995.4	6.5	4,590
