Fargo, ND | HEI No. 1915-0241

September 30, 2019

ENGINEER'S DESIGN REPORT – ADDENDUM #1

Lower Otter Tail River Channel
Restoration

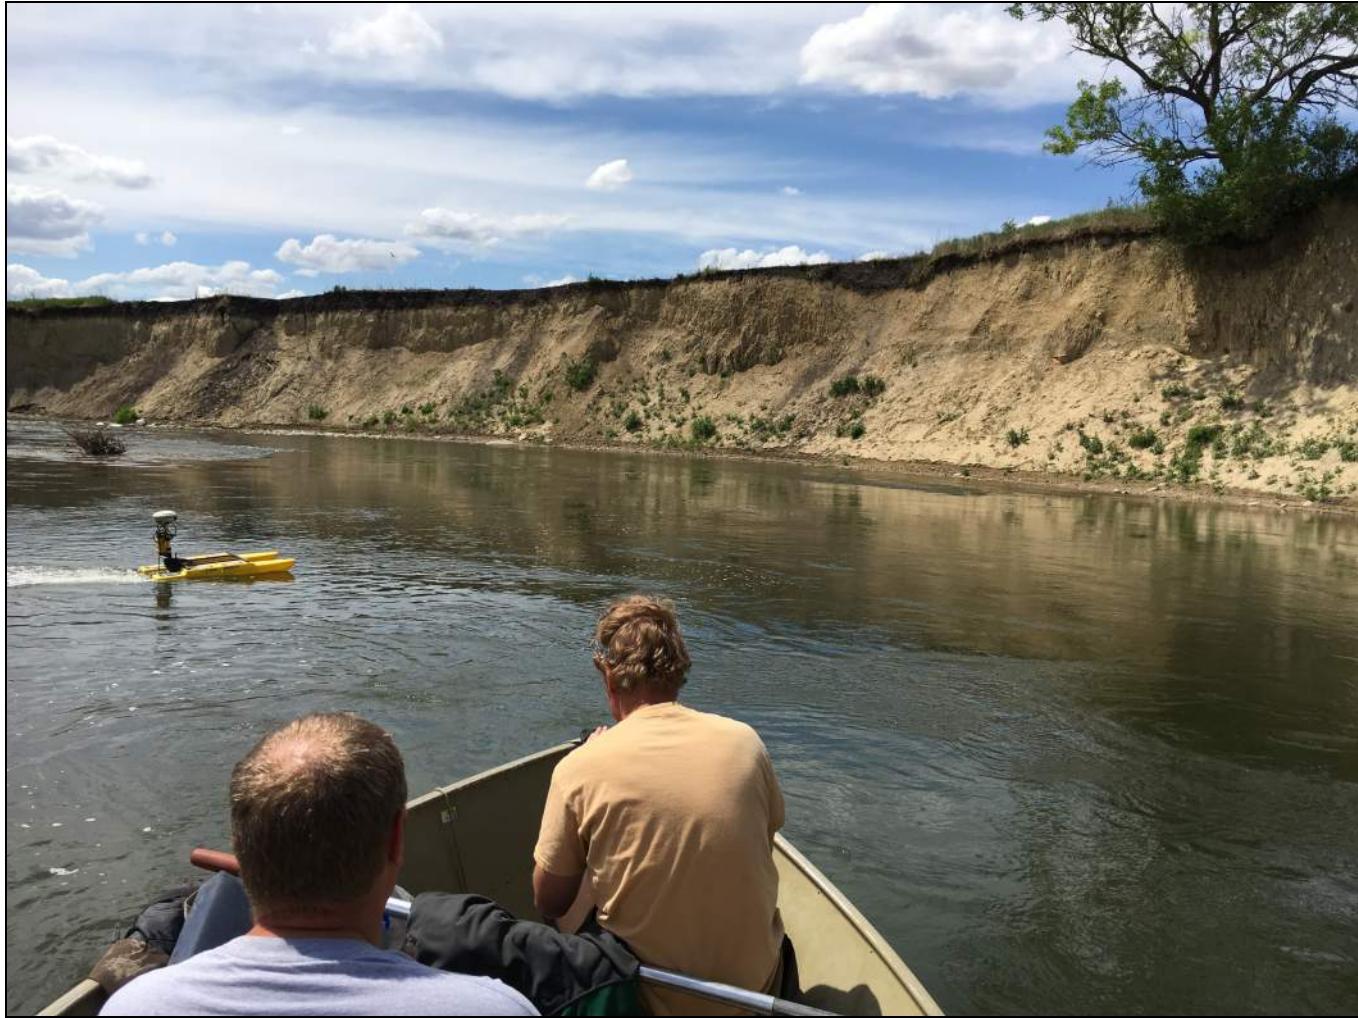
Photo 1 - River Elevation Survey
